December 23, 2019

RE: **Phase II Investigations and Evaluations**
Harrisville Pond Dam
Burrillville, Rhode Island
(Pare Project No. 19010.00)

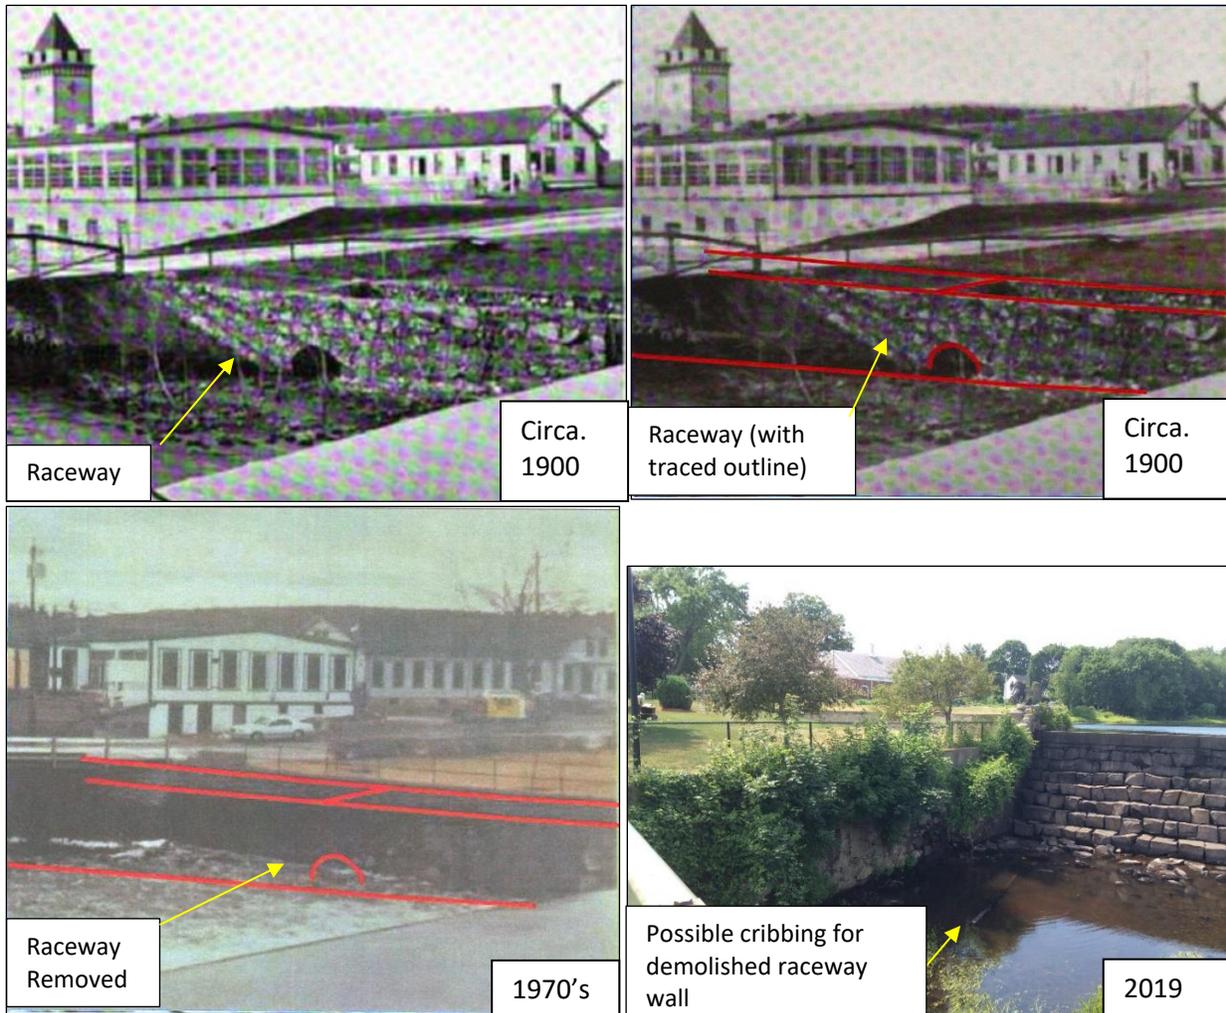
- A. *Historic Raceway:* In Pare's previous report, a circa 1900 photo of the spillway discharge channel's right wall appeared to show a stone masonry raceway directly behind the existing right wall. Through additional research, an inspection photo taken in the 1970's from the same viewpoint reveals that the old raceway was built in front of the existing wall, so the wall shown today is actually the former raceway's right wall. There is also a stone arch opening on the right wall which is still seen today. It is likely that a pipe penetrated the raceway. Whether this assumed pipe functioned as a discharge for the former outlet or a pipeline crossing is unknown.

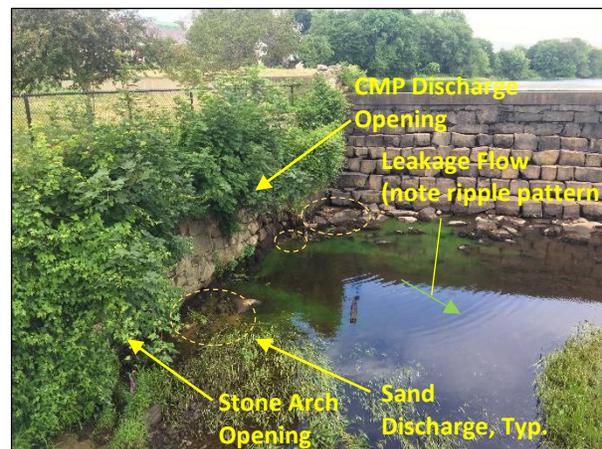
B. *Dye Testing*: On July 17th, 2019, a second dye test was completed at the abandoned outlet. At the time of the test, the impoundment levels were below the crest of the spillway and the low-level outlet gates were closed; therefore, eliminating turbulent conditions. The test involved releasing about 10 ounces of green dye near the hole in the abandoned gate. Within minutes the dye could be seen flowing from the base of the primary spillway right training wall from the base of the spillway steps to the stone arch opening about 40 feet downstream as shown in the attached photo. Higher concentrations of dye appeared to flow through wall areas upstream and downstream of the CMP with visible sand discharge fans at these locations.

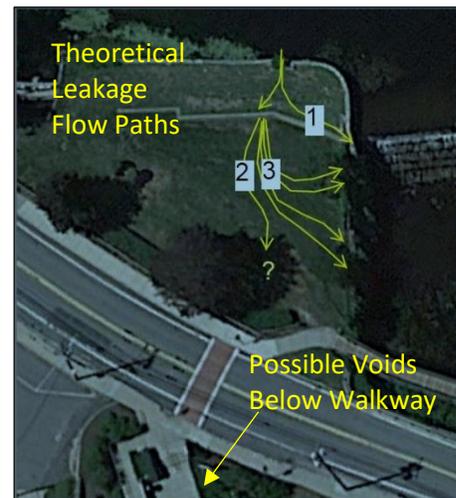
Water enters the hole in the gate, passes perpendicularly through the embankment to the zone of buried riprap or boulders behind the downstream wall and flows to the right then passes through a possible opening at the base of the downstream wall. Once passing through the downstream wall, the majority of leakage flows in a leftward arch pattern and exits out the base of the spillway's right training wall in areas upstream and downstream of the 48-inch CMP discharge. It is believed that the leakage through the wall is reduced in the area of the CMP discharge because it flows into the CMP through an open joint about 30 feet upstream of the discharge. The open joint was found during Pare's previous investigation and is presented in the respective report.

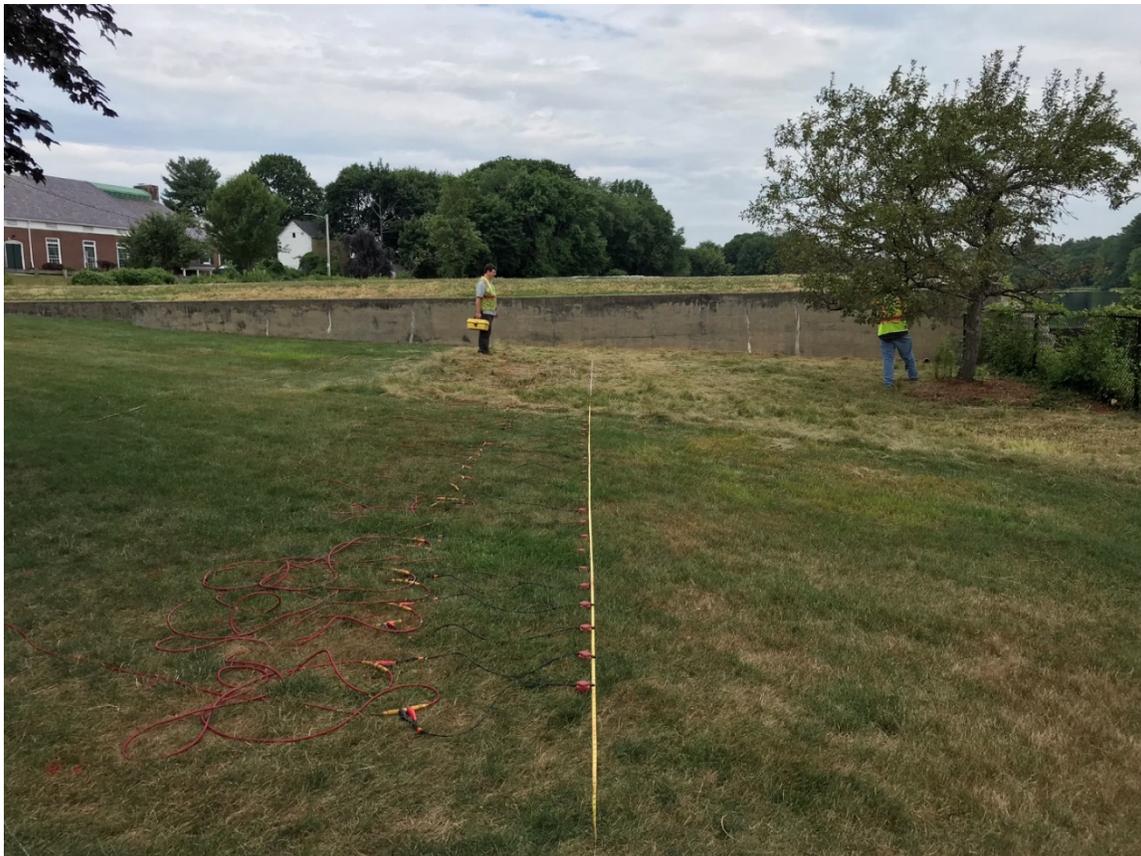
Photograph 1. MASW line across the area of interest at Harrisville pond Dam, view to the northwest. The MASW geophones are the orange objects located along the yellow tape. The 3-ft diameter, 2-ft deep sinkhole is in the taller grass between the two people. The spillway is located to the right, on the other side of the chain-link fence, and the pond is behind the retaining wall and raised grassy area in the background.

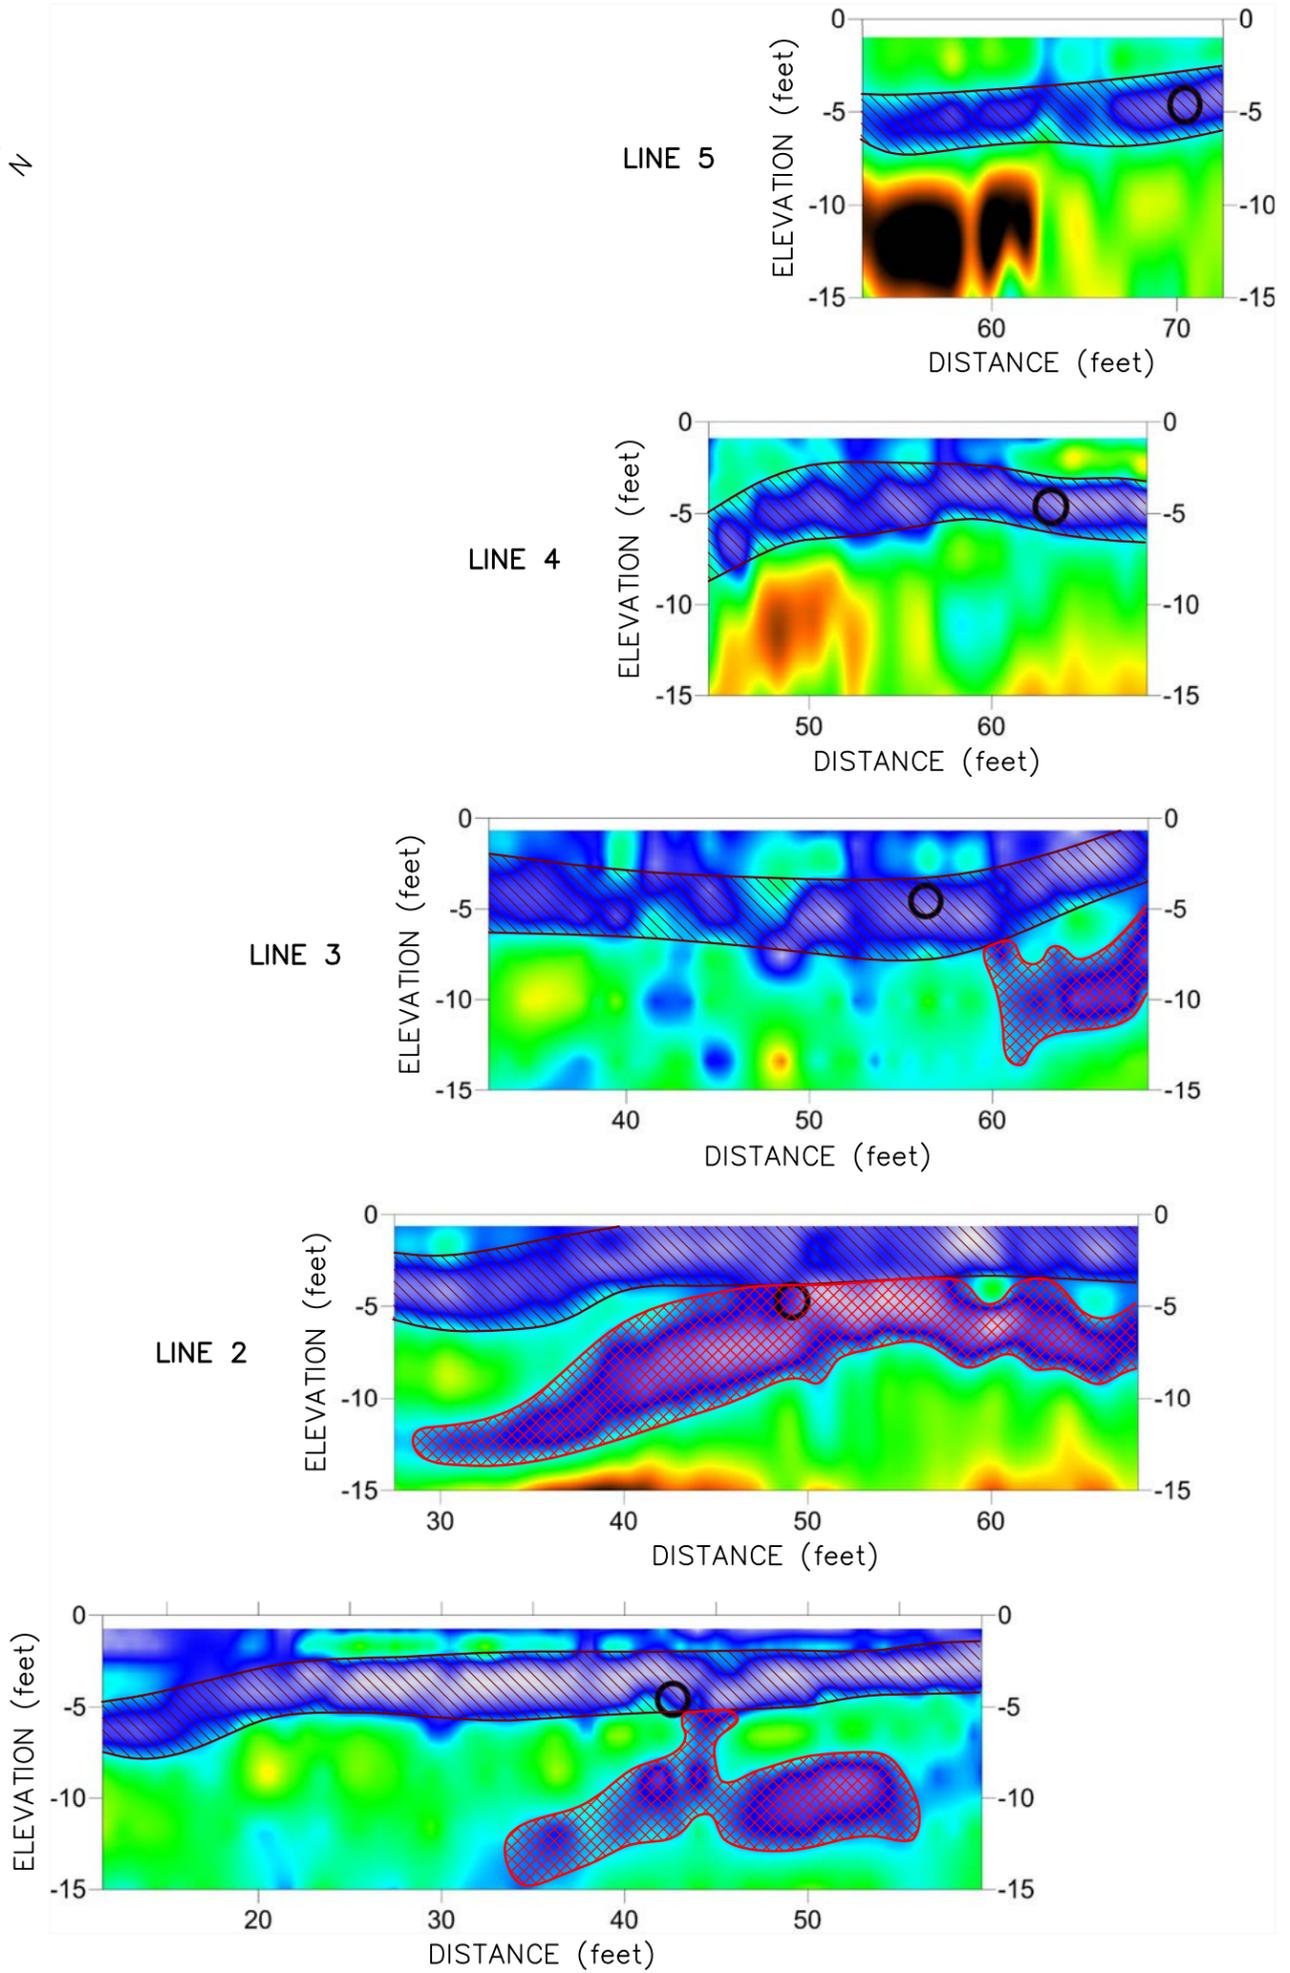
Possible areas of near-surface voids or zones of loose soils were detected in the east portion of the area and their locations are shown as brown honey-combed areas in Figure 4. Such zones are

typified by zones of low GPR signal strength, disturbed layering, or ringing. The tops of the areas of the near-surface voids or loose soils are typically 1 to 4 feet deep. Such zones of near surface voids or zones of loose soils are located near the 48-inch steel culvert and the former raceway intake. An example GPR record across an area of possible near-surface voids or loose soils is shown in Figure 5

Zones of low velocity (<500 ft/s) materials interpreted to be possibly caused by voids or loose soils are present along the MASW lines in the east portion the area of interest and their locations

are shown in Figure 6. Such zones are located below the near-surface low velocity strata discussed above, and were detected on MASW Lines 1, 2, and 3 at depths ranging between about 4 and 15 feet below ground surface. The velocity zone possible due to voids or loose soils extends under the majority of MASW Line 2, possibly reflecting the fact that Line 2 is located near the area of a former northwest-southeast oriented historic raceway.
