December 23, 2019

RE: **Phase II Investigations and Evaluations**
Harrisville Pond Dam
Burrillville, Rhode Island
(Pare Project No. 19010.00)

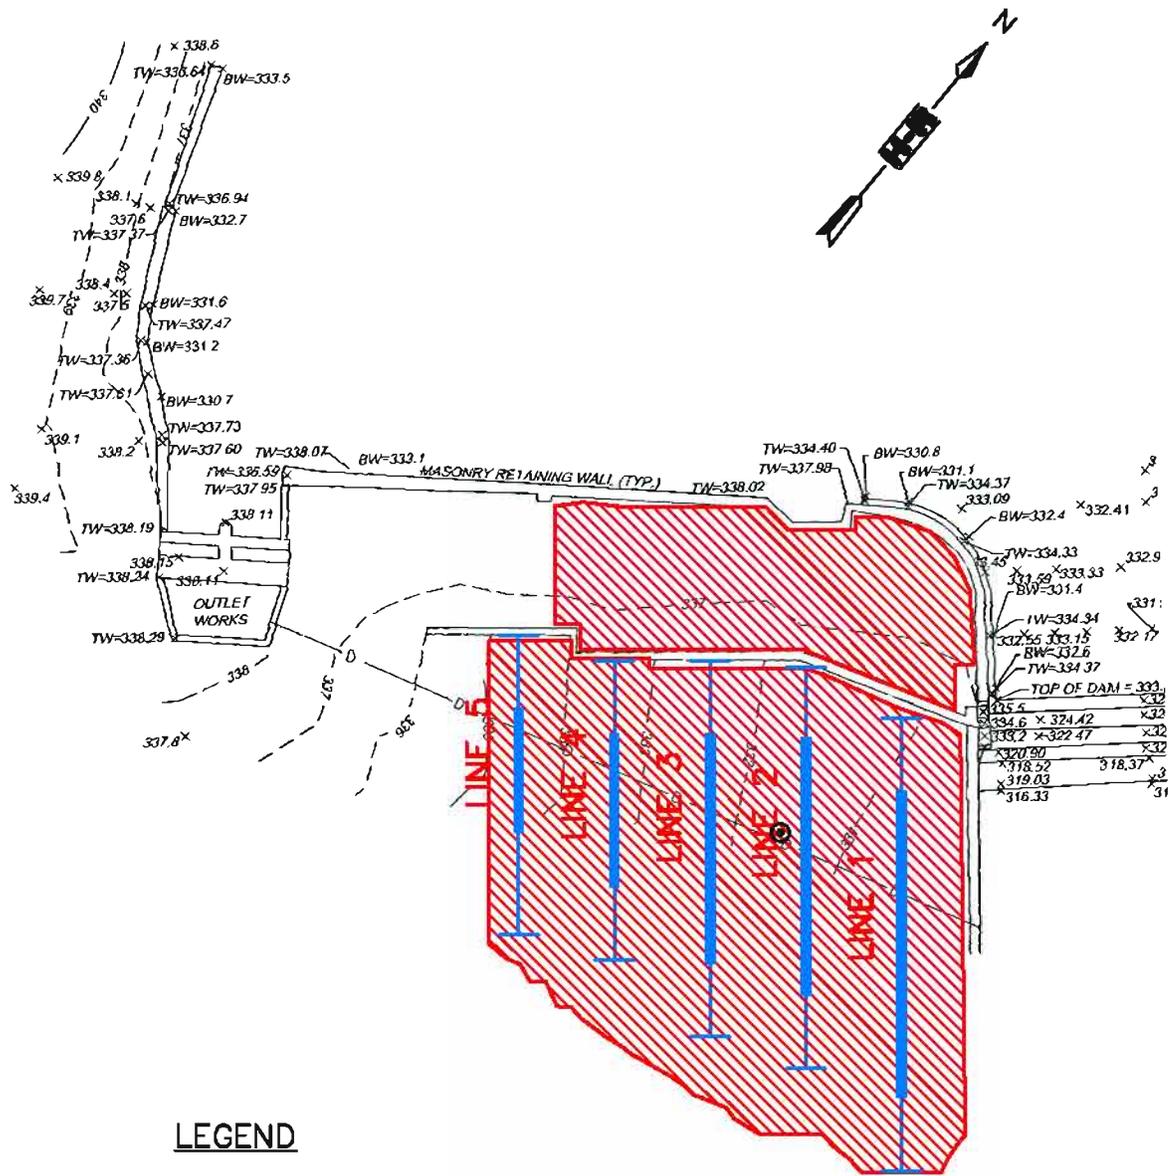
<p>Figure 2 Site Plan East Avenue & Steere Street Burrillville, Rhode Island</p>	
<p>File 19SG06</p>	<p>August, 2019</p>
<p>HAGER-RICHTER Salem, NH Fords, NJ</p>

The area of interest (AOI) for the survey covers approximately 10,000 square feet, is mostly grassy, and includes a concrete retaining wall that crosses approximately west to east through the center of the AOI. An approximately 3-foot diameter, 2-foot deep sinkhole has opened up recently and was present at the time of the survey near the center of the AOI. Reportedly, sinkholes have formed and been repaired over the years in the vicinity of the current sinkhole. Figure 2 shows the locations of the area of interest and the sinkhole present at the time of the survey.

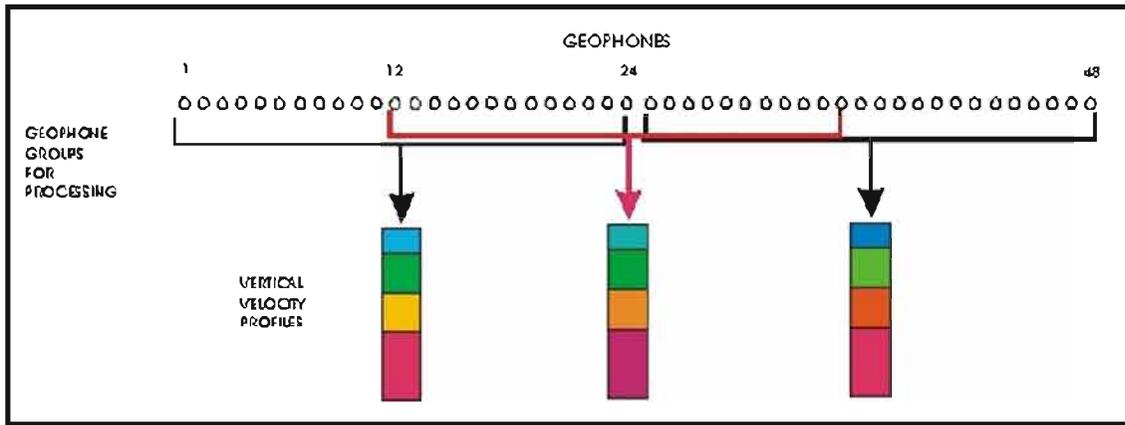
Figure 3 MASW Method East Avenue & Steere Street Burrillville, Rhode Island	
File 19SG06	August, 2019
HAGER-RICHTER Salem, NH Fords, NJ

Figure 3 shows the data acquisition scheme and the way in which processing produces 24 vertical velocity profiles for a 48-geophone spread. As shown in Figure 3, a series of the first and last geophones do not yield velocities as function of depth at each of those 24 geophone locations. Due to the MASW array configuration for the current project, the first and last approximately 11.5 ft section of each MASW line does not exhibit results, as shown in the MASW plots in Figure 6.

MASW. The MASW method determines the spatial variation of shear wave velocity along the transects. In general, lower shear wave velocities indicate softer soils while higher shear wave velocities indicate more dense materials. Please note that due the acquisition parameters for the MASW arrays, as explained in the Equipment and Procedures section, results cannot be determined for the first and last approximately 11.5 feet of each MASW transect, as indicated in Figure 3.

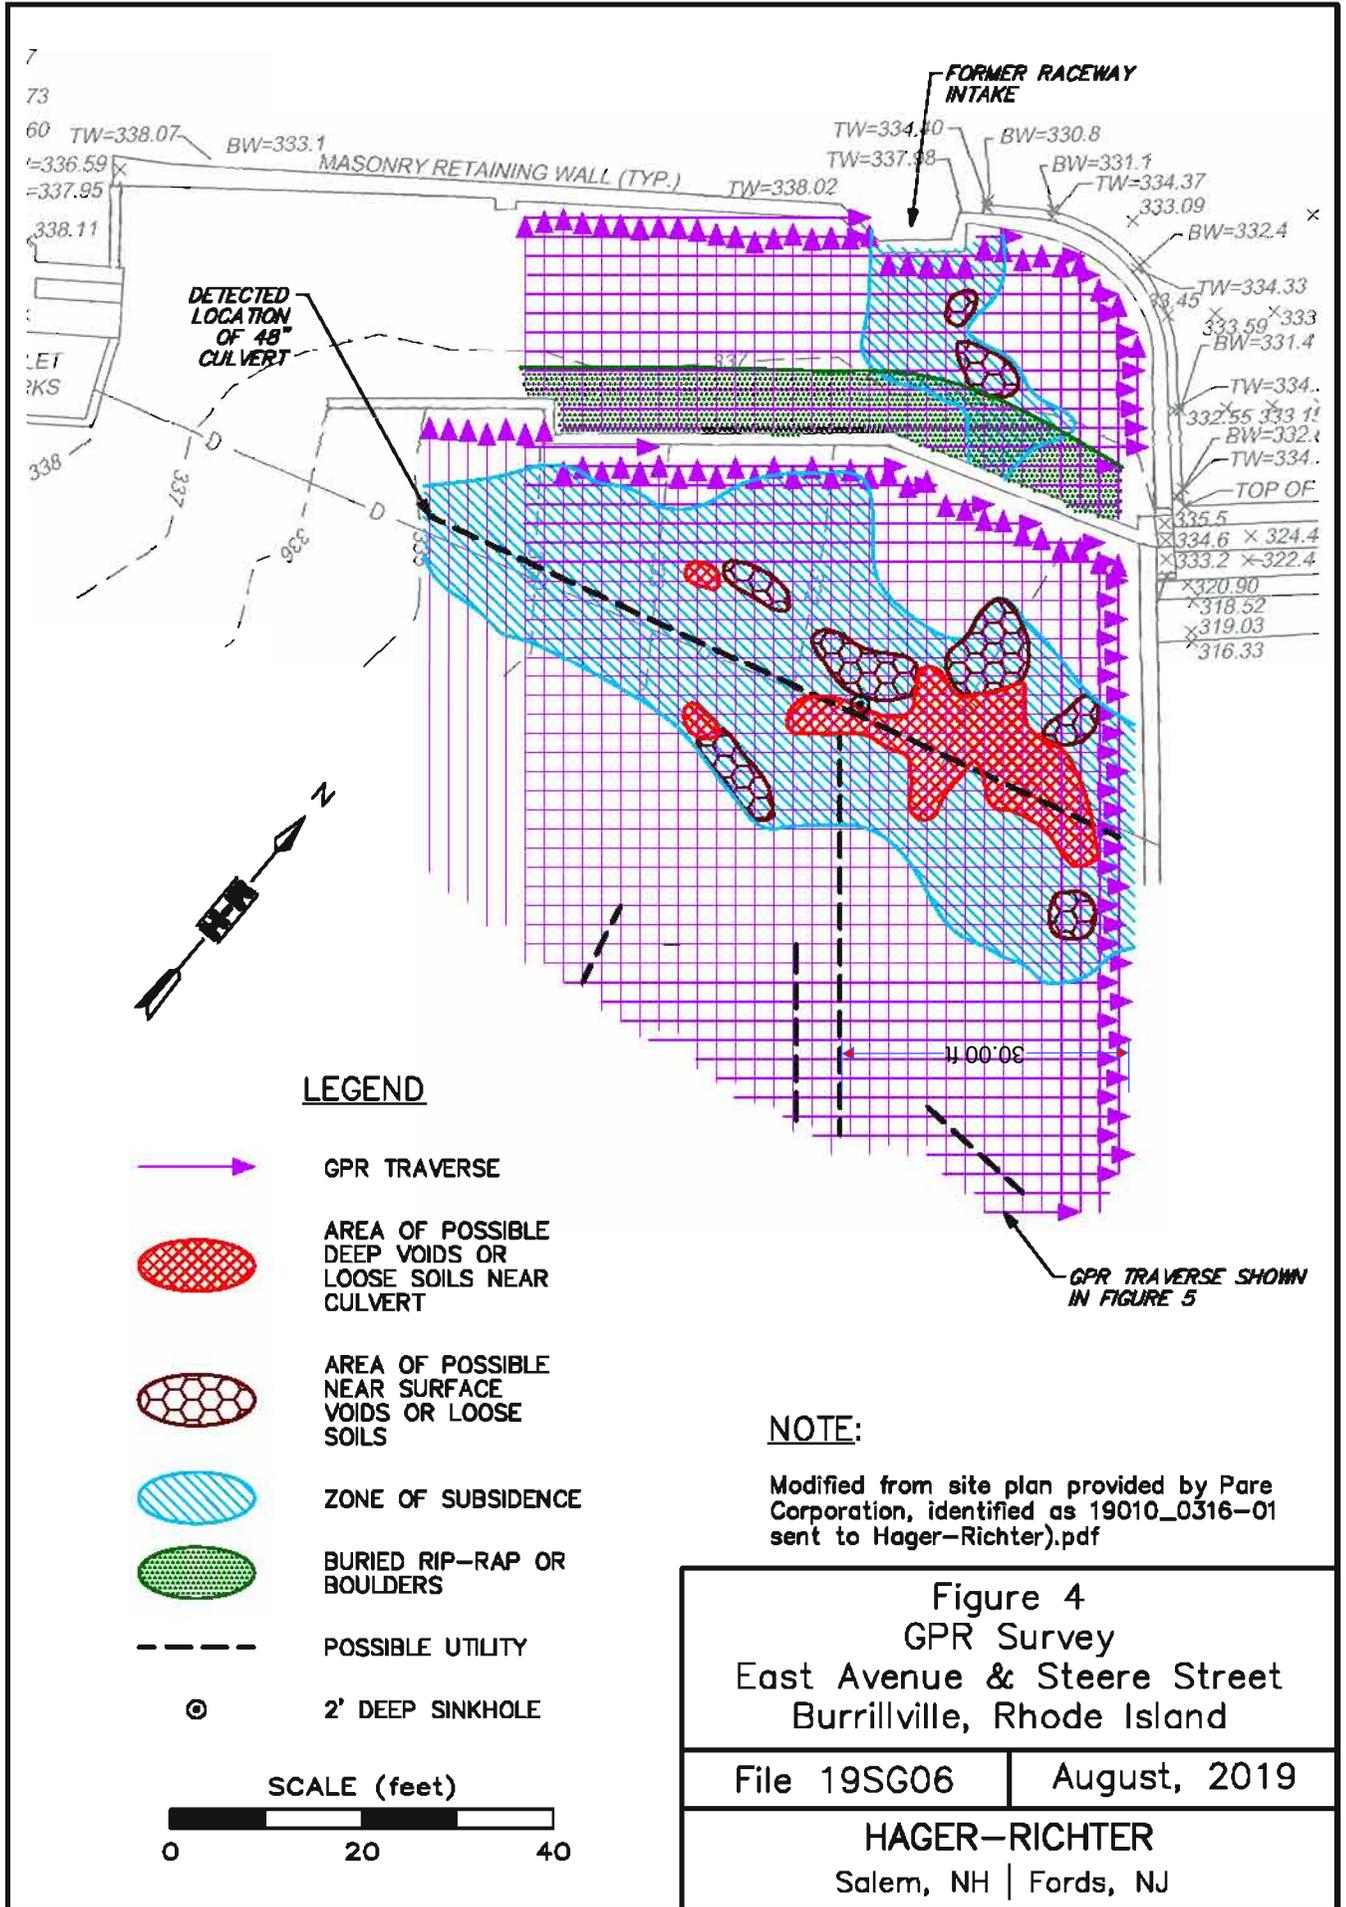
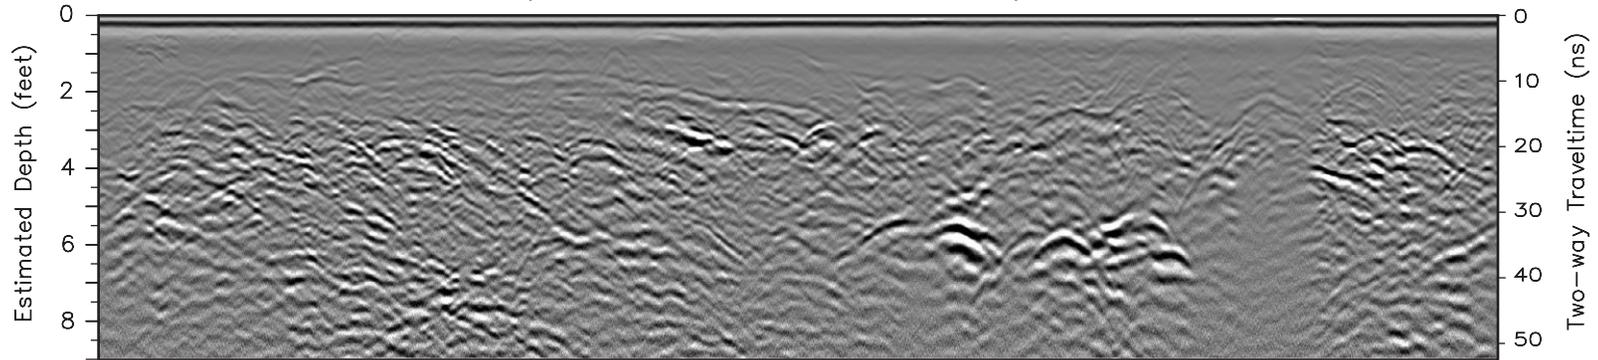
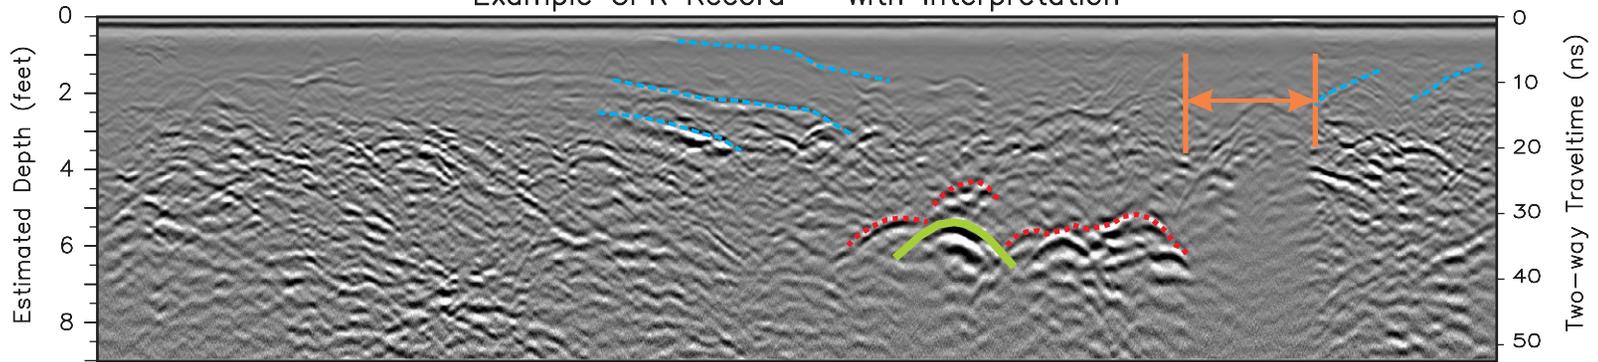
TOP OF POSSIBLE DEEP VOID OR LOOSE SOILS
-

ZONE OF POSSIBLE NEAR-SURFACE VOID OR LOOSE SOILS
-
